Manhole Inspection Summary

Manhole # S29K1_010MH

Inspection ☐ Is Incomplete Rating: **3) Fair**

Location Address: **2300 Round Rd.**

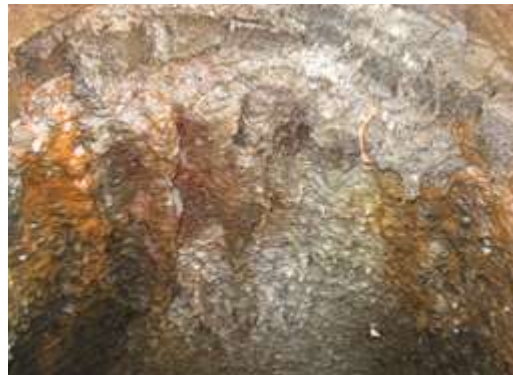
Defect 1

Infiltration: ☐ None ☒ **Joint** ☐ Cracks ☒ **Mortar** ☐ Roots ☒ **Wall**

Infiltration: ☐ None ☐ Joint ☐ Cracks ☒ **Mortar** ☐ Roots ☒ **Wall**

Infiltration

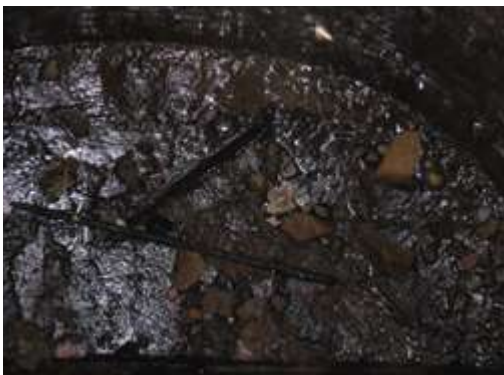
Defect 2

Bench

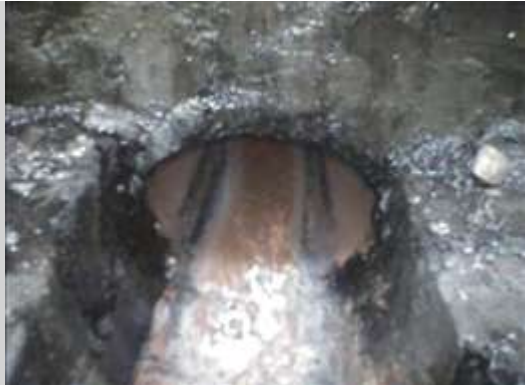
12 O'Clock Outflow

8 in. Circular Gravity Sewer
Pipe Out @ 12 O'Clock

Pipe Height: **8.4** (in.) Rod and Bar (Angled)
Pipe Material: **Clay** ☐ Pipe Lined
Invert Depth: **9.91** (ft.) Flow Characteristics: **Fast**
Deposits: ☒ None ☐ Mud ☐ Sludge ☐ Debris ☐ Grease
Silt Depth: (in.) Deposits Extent:
Infiltration: **None** Pipe Seal Cond: **Sound**

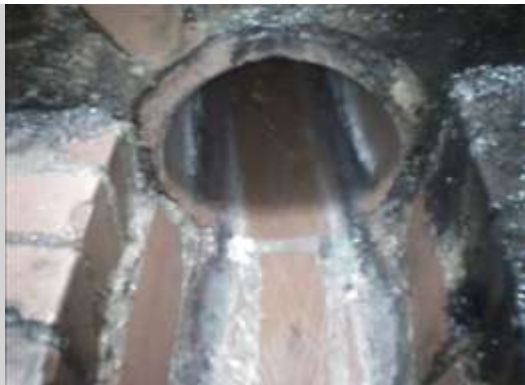
6 O'Clock Inflow

8 in. Circular Gravity Sewer
Pipe In @ 6 O'Clock

Pipe Height: **8.4** (in.) Rod and Bar (Angled)
Pipe Material: **Clay** ☐ Pipe Lined
Invert Depth: **9.47** (ft.) Flow Characteristics: **Fast**
Deposits: ☒ None ☐ Mud ☐ Sludge ☐ Debris ☐ Grease
Silt Depth: (in.) Deposits Extent:
Infiltration: **None** Pipe Seal Cond: **Sound**
